I.C. Engine Cycles

Engine Polygraph Background
2017-11-16

This signature is from a C14 Caterpillar 2003 engine with 1,300,000 miles. It was brought in because the vehicle produced a 78 opacity test.

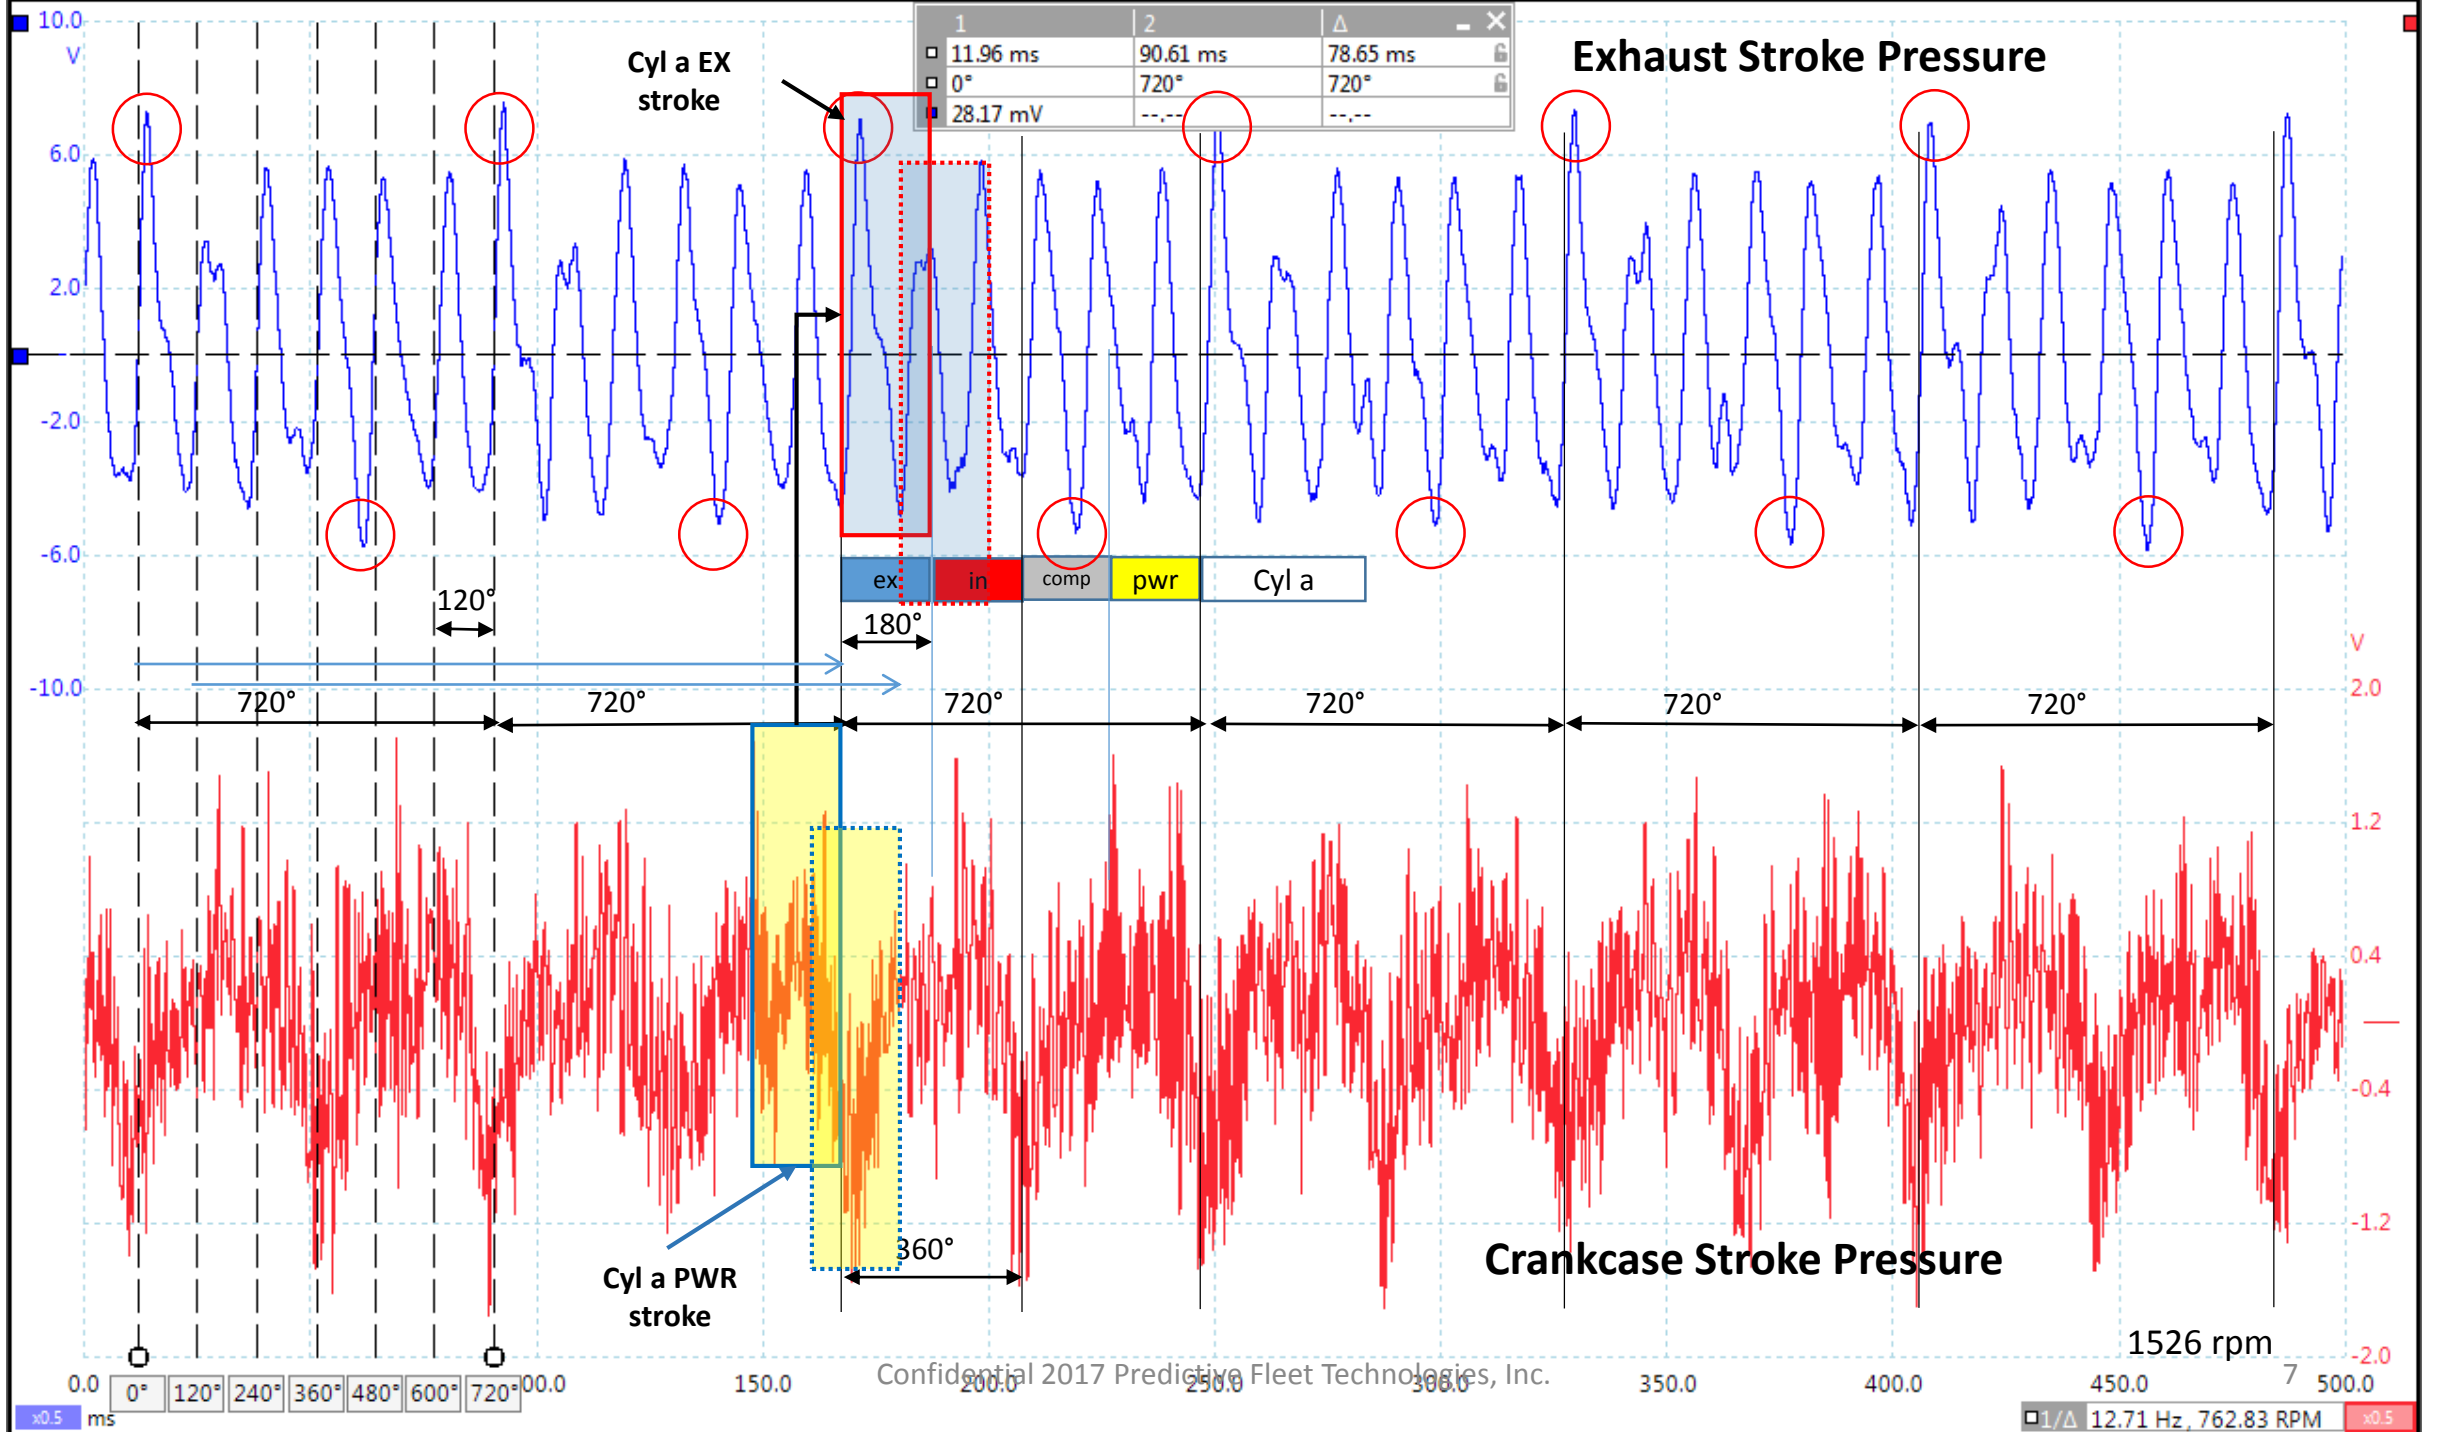
Exhaust Stroke Pressure

- Defects in cylinder waveforms (red circles) help define the 2-revolution cycle when each cylinder experiences each stroke once (assuming that each cylinder does not experience the same defect to the same intensity).
- Shown in the center of the blue waveform in the diagram on next page

- Each cylinder has one exhaust stroke during the 720° cycle, causing a 120° mini-cycle as each piston moves most of its exhaust out of the associated cylinder
- On the far left side of diagram on next page

When the 4-strokes of each cycle are stacked in firing order, we see that each cylinder is 'doing something' at each instance.

- The 720° cycle is split into 180° stroke sections and also into 120° cylinder sections. This provides a set of 12 x 60° sections.
- The exhaust (blue) in a good engine has 2 cylinders with partially open exhaust valves 2/3 of the time. In the middle third of the stroke, when the piston is moving the fastest, only one cylinder is exhausting.

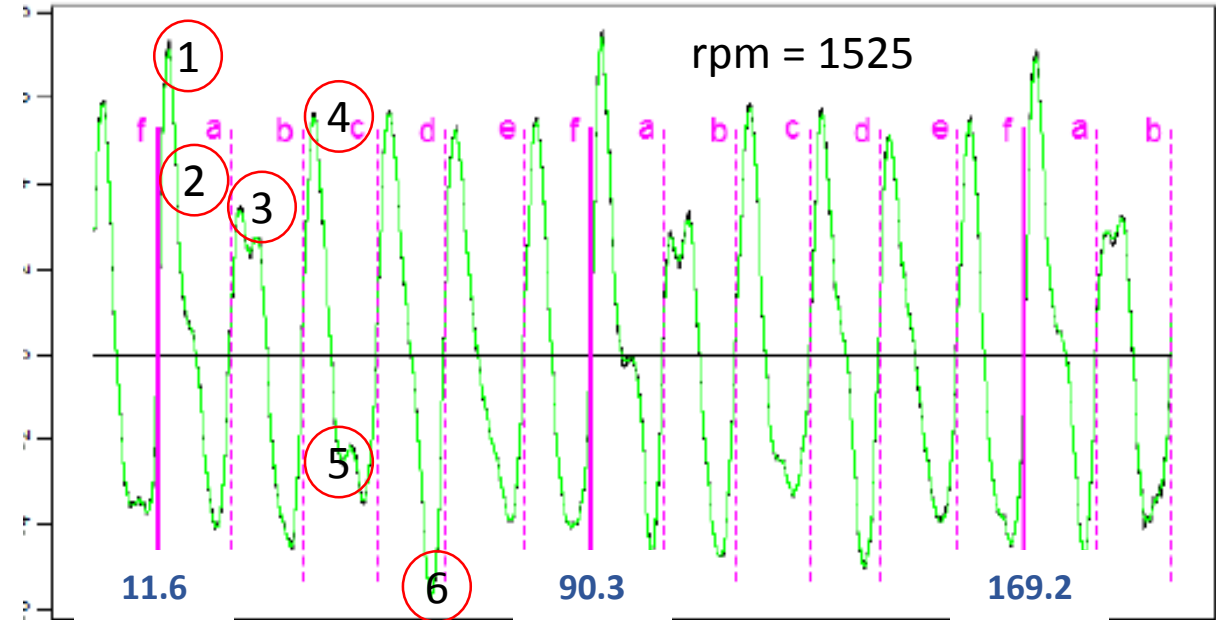
- Each engine cycle has one peak that exceeds the others and one that is much less than the others. This is typical for 'mis-fire with fuel' when the power stroke before the low exhaust 'peak' doesn't burn the fuel so the fuel goes out the exhaust. Then when the unburnt fuel hits the catalytic convertor (or other 'hot spot' in the exhaust), it flashes with the exhaust from another cylinder. This results in a spike that would occur a short time **after** the mis-fire exhaust – NOT before it.

But in this case, the high peak immediately **precedes** the mis-fire exhaust stroke, so there is more to the story.

- 'Forks' at the peak of a cylinder indicate valve overlap at the exhaust closing (and intake valve opening early while the exhaust is still open).
- 'Forks' at the bottom valley indicate the intake valve closing and the exhaust valve opening with overlap.

So we **hypothesize** that the cylinder in exhaust stroke, b, on the next page has an exhaust valve that cannot close very completely (not even tight enough to give a characteristic high frequency when a **little** carbon prevents a tight seal).

The exhaust in the a-b-c is not highly correlated with d-e-f, so there are some issues either with the PCV valve or possibly blow-by. But this looks minor compared with the valve issue with cylinder b.

1. In the time when a is exhausting, b is in its power stroke. But b is a mis-fire because the exhaust valve partially open would not allow the poor compression to cause ignition.

2. Because b can't ignite and its exhaust valve is partially open, fuel is flowing with the air out the exhaust and is (poorly) burning, increasing the peak of a's exhaust with a lot of soot.

3. Now b starts its exhaust opening the exhaust valve while the piston pushes out some more air as a mis-fire pulse.
4. Nothing yet bothered c so it gives a healthy exhaust after its power stroke.

5. Near the midpoint of c's exhaust, b is now in its intake stroke, giving the hump in c's exhaust before c's exhaust was closed.
6. Near the mid and end of d's exhaust, the vacuum of b's intake is maximum and pulls some vacuum through the partially open exhaust, enhancing the exhaust after d's main pulse of exhaust was completed.

1. A quite large amount of carbon might be preventing b's exhaust valve from closing.
2. The valve spring on b might be very weak or broken.
3. The exhaust valve might be defective: chipped lip or cracked.
4. The valve lash for b's exhaust valve might be way off.

- Cheapest possible solution is to put a fuel additive (Oxytane) in the tank and drive the vehicle (ideally with a load) for 30 minutes.
- If that doesn't help, open the valve cover and investigate the other possible causes.

The Oxytane was used and the 'After' signature was run. It is shown on the next page.
