# Engine Polygraph® (enginepolygraph.com)

## Diagnostic Report v6.00

## Introduction

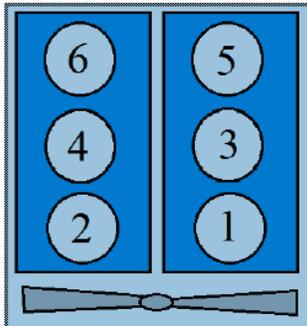
Engine Block Layout

Cylinder	Adj1	Adj2
1	3	
2	4	
3	5	1
4	6	2
5	3	
6	4

Bank	Cyl	Firing Order
1	1	a
1	3	c
1	5	e
2	2	b
2	4	d
2	6	f

Adjacent Cylinder Pairs of Head Gasket Concern	Risk Level
Adjacent Cylinders on Bank 1 are simultaneously in Power & Intake strokes	<b>Raised</b>
Adjacent Cylinders on Bank 2 are simultaneously in Compression & Intake strokes	<b>Raised</b>

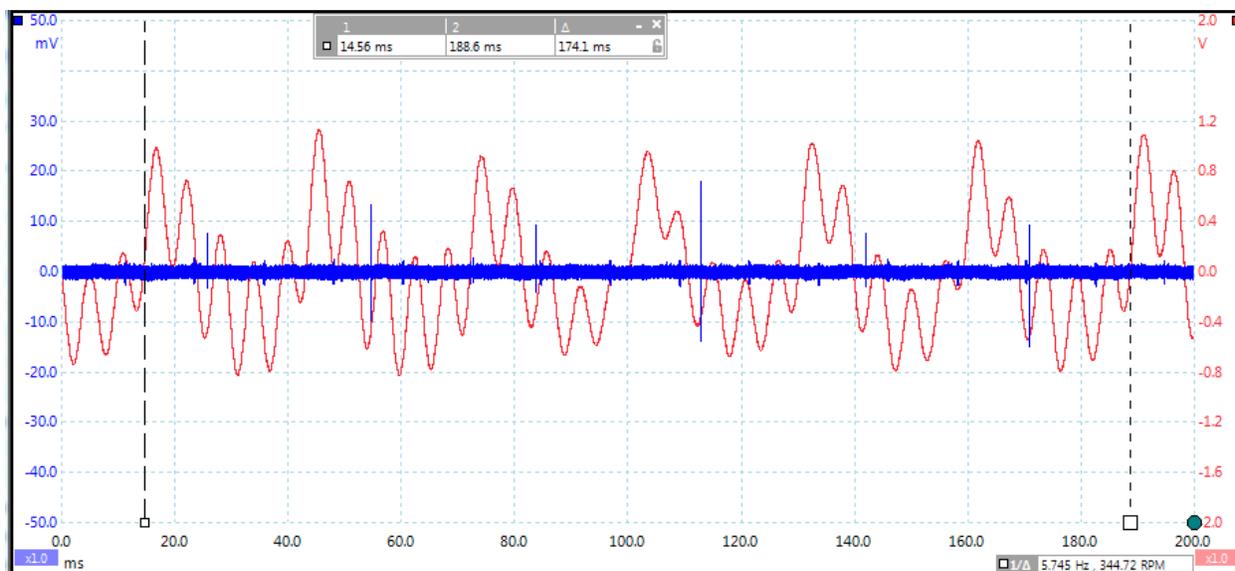
Figure 1: A SenX Signature using a PicoScope PC Oscilloscope.

The above signature is from the exhaust (red) and a 'trigger file' from a spark plug induction clamp (blue) from a 6 year old, V6 engine. The vertical dashed bars mark the boundaries of a 720° full 2 rotations of the crankshaft which took 174.1 ms, indicating that the engine was running at idle of 691.7 rpm. (You might notice that the oscilloscope indicates the rpm as 344.72 in the lower right corner. But we know that we have a 4-stroke engine requiring 2 rotations for all cylinders to fire once and this is a V6, so the rpm is twice the frequency of the 4-stroke frequency.) The cylinders are very regular.

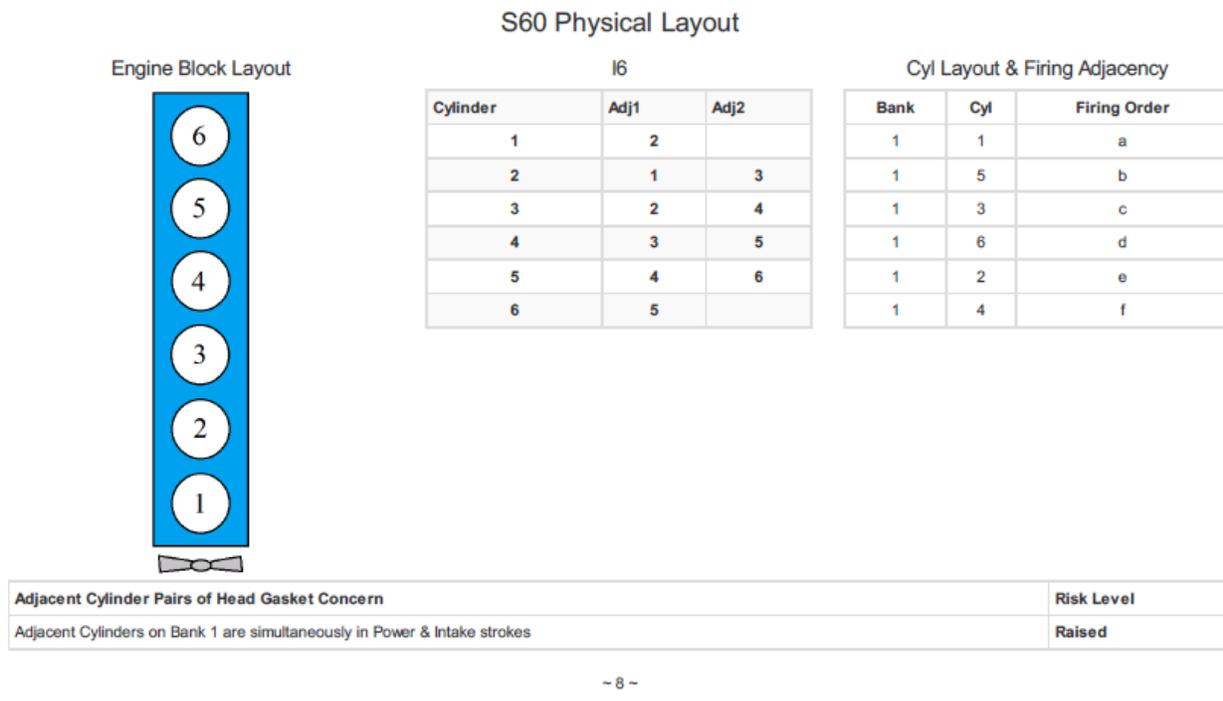
Figure 9: Example Engine Block Layout, Cylinder Adjacency, Bank Alignment and Firing Order.

The next page (Fig. 9) provides an illustration of the engine block with the cylinders numbered according to the manufacturer's documentation (or as we have found it in the published literature). In addition, there are two tables:

If there are pairs of cylinders that are neighbors that hit are simultaneously in a power and intake stroke, the bank of the engine that exhibits that situation is listed and a value for a "risk level" is indicated to alert the reader to the concern that a gasket rupture between those two cylinders is somewhat more likely that at that situation does not present itself. If an adjacent

set of cylinders are simultaneously in a compression and intake stroke. A similar statement is issued with a less severe warning about risk.

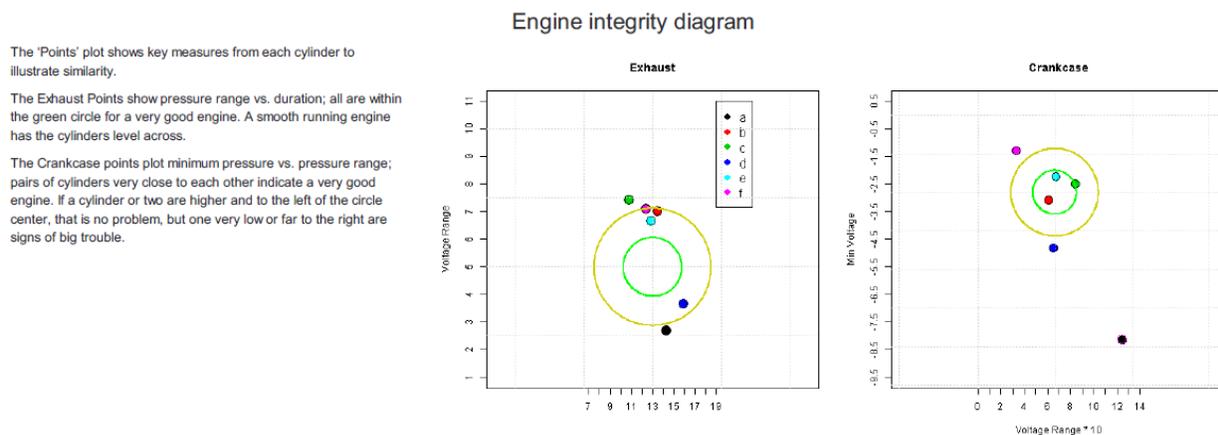
Figure 11: Engine Integrity diagram showing the (dis)similarity of the value of parameters for each cylinder derived from the Signature data.

The Engine Integrity Diagram shows values of key parameters for each cylinder. The cylinders are named alphabetically (a, b, c, etc.) in firing order sequence with unknown starting cylinder location. We call this the *Engine Integrity diagram* because if the points are close together, the engine has high integrity since all cylinders have similar operating parameters. (We are making the assumption that an engine would not have all cylinders in equally **bad** condition.) The green radius is would contain the points for most engines with score of 3 or better; the yellow circle would contain the points for most engines with scores 6 or better. The voltage is directly proportional to the pressure. (See Fig. 110.)

In the Exhaust graphic, the cylinder Duration is the number of milliseconds the exhaust from the cylinder takes to pass the exhaust sensor, when the engine cycle is normalized to 1500 rpm. (The Profile chart below might allow easier interpretation of the number of ms.) If the difference between the fastest and slowest cylinders exceeds 4 ms, the engine is running 'rough'. The vertical axis of the Exhaust chart shows the maximum voltage (pressure) observed by the sensor during the exhaust stroke for each cylinder. As you might expect, a cylinder with high exhaust output had a very successful power stroke and so the exhaust cycle should be fast due to the acceleration of the power stroke. (So it will show in the upper left of the cluster.) Similarly, low voltage implies low cylinder output and so a slower exhaust cycle; such a cylinder would present in the lower right of the cluster.)

In the Crankcase chart, the x-axis is the voltage range for each cylinder (maximum minus minimum) whereas the vertical axis is the minimum voltage. Severe blow-by exhibits as a very large dip in the minimum voltage associated with the cylinder vacuum of the intake stroke.

Each cylinder in firing order is assigned a unique color that can be used to 'see' the same cylinder on the various graphics.

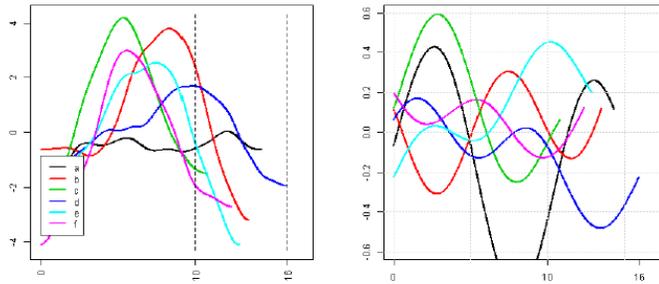
Figure 12: The Profiles graphics for the exhaust and crankcase for each cylinder.

The Exhaust Profiles show each cylinder's exhaust pressure for its section of the cycle. The cylinders are identified in firing order with colors; the legend shows the cylinder letter identifier with the assigned color. In a good engine, the profile lines are very similar. If one is much higher than the others, that is a sign that a bad injector might be putting too much fuel into the cylinder - or that another earlier exhausting cylinder might have a mis-fire with fuel. If a cylinder exhaust is significantly shorter than the others, the cylinder might have had a mis-fire, a head gasket leak, or blow-by into the crankcase.

The Crankcase Profiles show the crankcase pressure from all cylinders actions during each cylinder's section of the cycle. These lines are usually arranged in pairs since the crankcase patterns repeat every 360° so each cylinder in the first 360° should have a match in the second 360°. Pressure variations are from the intake manifold through the PCV valve (vacuum pulls) and from blow-by (either from the intake stroke pulling air/fumes from the crankcase to the cylinder interior or from the compression stroke and the power stroke when air/combustion products blow around the pistons/rings).

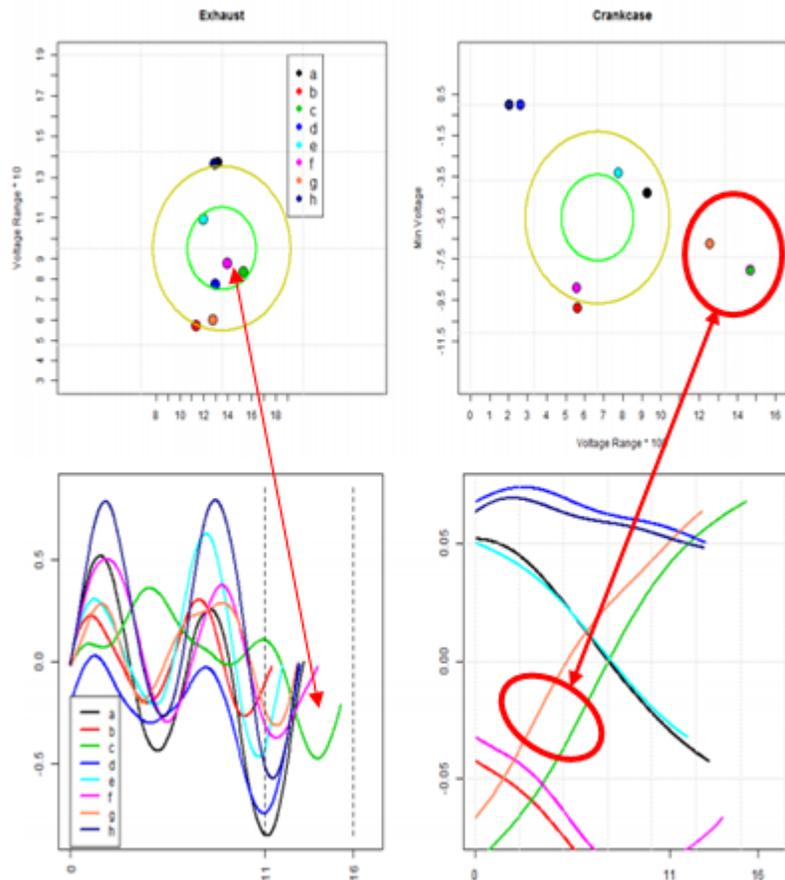
Figure 13: Illustration of using colors to relate data from differing graphics by cylinder.

Using a different engine's report, we illustrate the use of the colors for matching specific cylinders across the graphics. (See Fig. 13.)

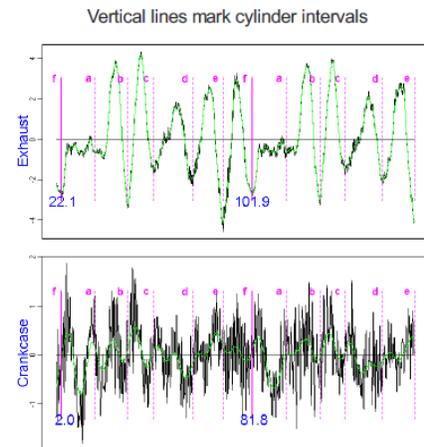
Figure 14: The Polygraph Model of the Pressure vs. vibration in the EP Signature for the subject engine.

In the Exhaust model, we mark cylinder boundaries with vertical dashed lines by analyzing properties of the curve. (A cylinder mis-fire might cause that calculation to be in error.) The average cylinder duration is the (cycle-time in ms)/ divided by the number of cylinders (Noyl). In a very good engine each cylinder should have at least one 'peak and valley'. If the engine is running properly, each cylinder's section should be the same. The cylinders are identified in the Exhaust Model by lower-case letter in firing-order. The numbers at the bottom of the graph show the relative time in ms since the start of the signature at each cycle.

Trigger on a 4-stroke engine: If a trigger sensor is available to identify the timing of ignition of cylinder 1 (or any other known cylinder as per the manufacturer's design), we know that the power stroke will immediately follow in that cylinder (for the next 180°). For our example engine, let's assume that we have a trigger signal on cylinder 1.
